Sluiceway Deflector Design as part of the Boundary TDG Abatement Program

The high pressure sluice gates at the Boundary Project have been modified to accommodate throttled flow by addition of steel deflector plates at the sluiceway exit to direct flow away from the gate slots to prevent damage to the gate system.

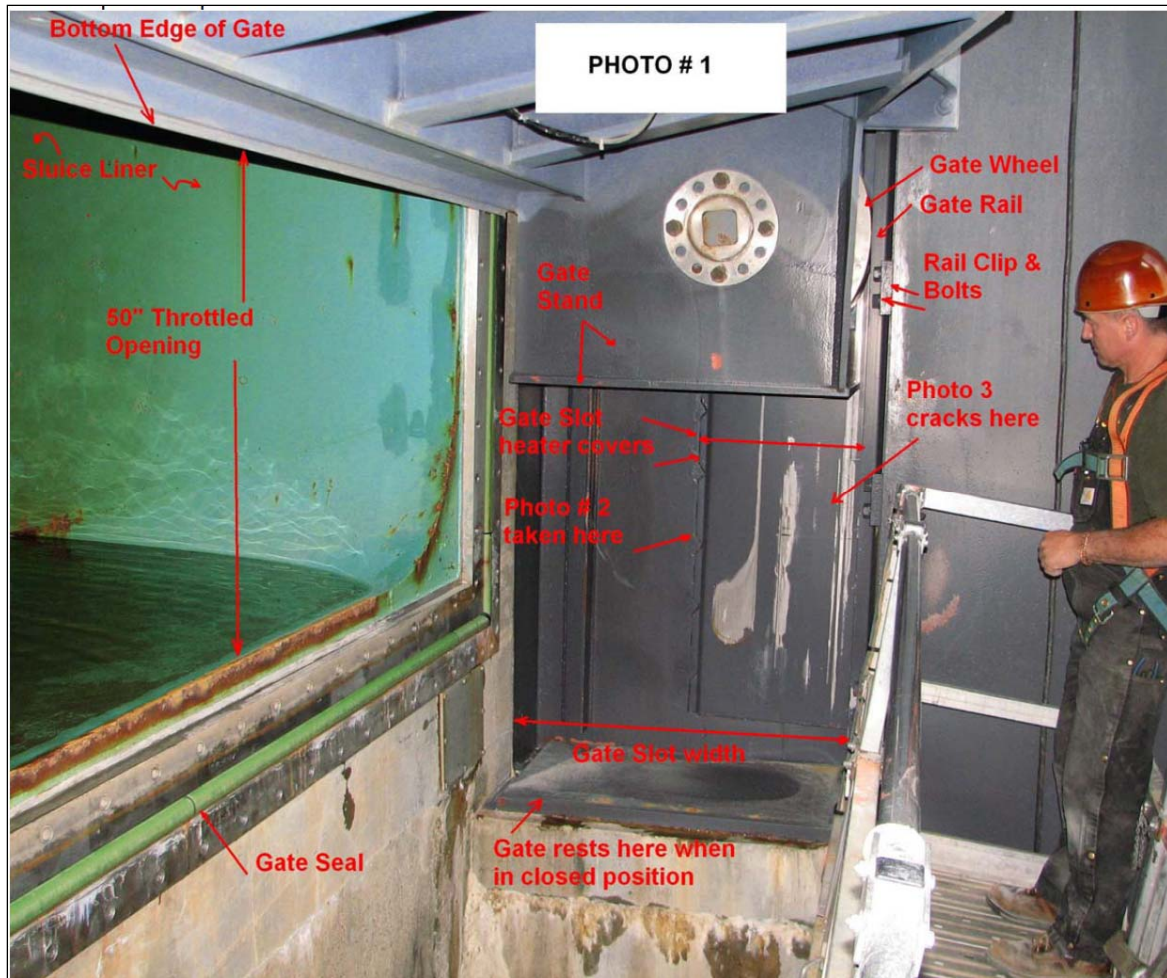
Figure 4. Details of Sluice Gate Slot

During testing on June 19, 2008, problems were identified when closing Sluice Gates 2 and 6. These gates had not yet been modified with seal plates, and the gate slot heat covers had been removed. An unusual noise was reported from Sluice Gate 4, and problems were also identified with closing Sluice Gate 4. At this point, all further testing was cancelled. Details of the sluice gate slots are shown in Figure 4.

Inspections identified that the Sluice Gate 4 gate slot heater cover welds had failed, which explained the trouble with closing. Sluice Gate 6 was also inspected and no problems could be identified as to why it would not close.

As discussed above, after throttled gate testing, the redesigned gate slot heater covers were found to have cracks over the covers. These cracks included weld cracks and there were fatigue cracks in the plates from vibration caused by the edges of the jet impinging within the gate slot. This damage was the result of the equivalent of 16.7 days of operation.

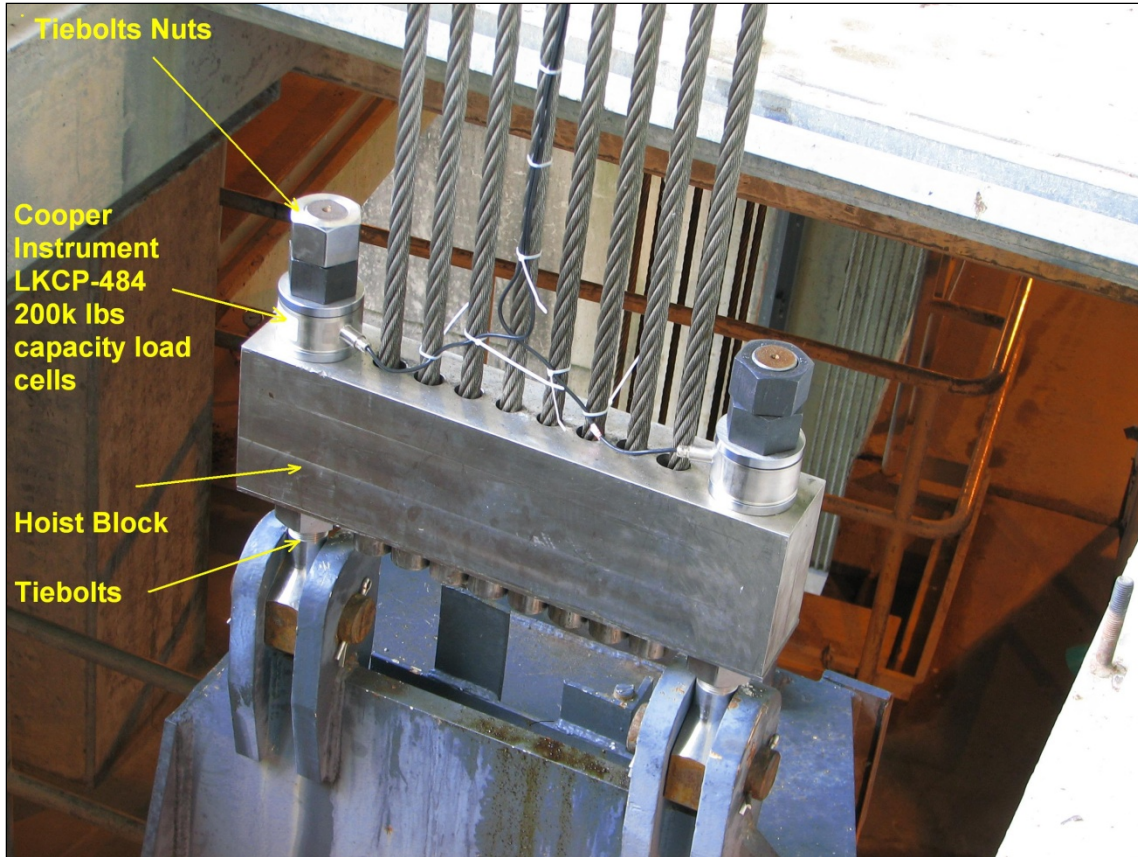
Figure 5. Hoist Load Cell Placement on Sluice Gate Lifting Block

The hoist capacity to raise and lower the gate was examined. SCL collected load data in May and June of 2010. Data were analyzed to extract the actual gate weight, the coefficient of friction in the wheel bushings, and other unknown vertical forces acting on the gate (see Figure 5). Hoist system analysis was updated to reflect load tests.

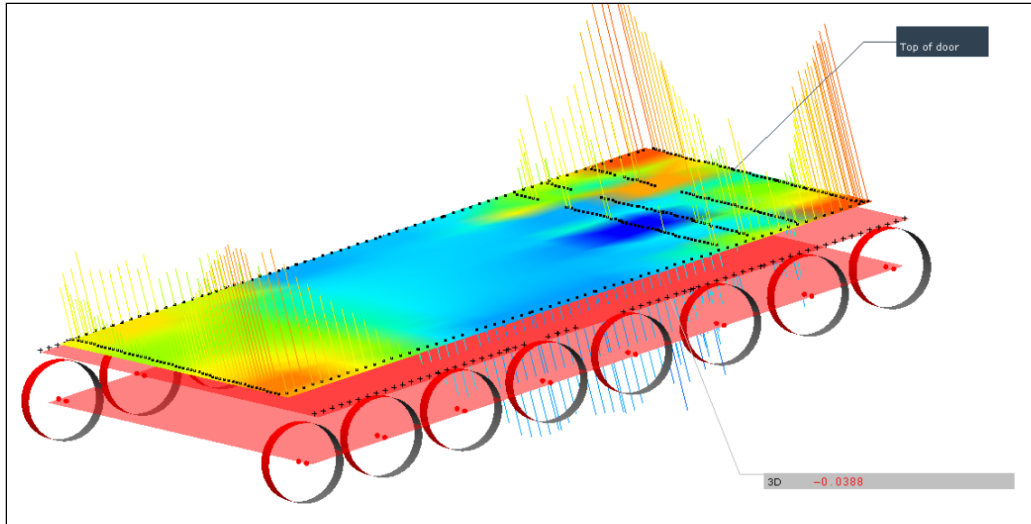
Figure 6. Metrology Measurements of Gate Alignment

OASIS was engaged to use 3D metrology and optical alignment to check the center Sluice Gate 4, (See Figure 6). The object of the exercise was to check if there are any interferences that could be causing the gate to jam when being lowered under full hydrostatic and hydrodynamic loading, particularly just before the gate fully lowers.

The results of the Metrology were not entirely conclusive however the conditions observed on site did not point to a geometry or alignment problem. The measured face alignment of the wheels indicated some “toe-in” as the gate is lowered that could result in increased lateral wheel loading which would somewhat hinder lowering. Interference was eliminated as an issue.

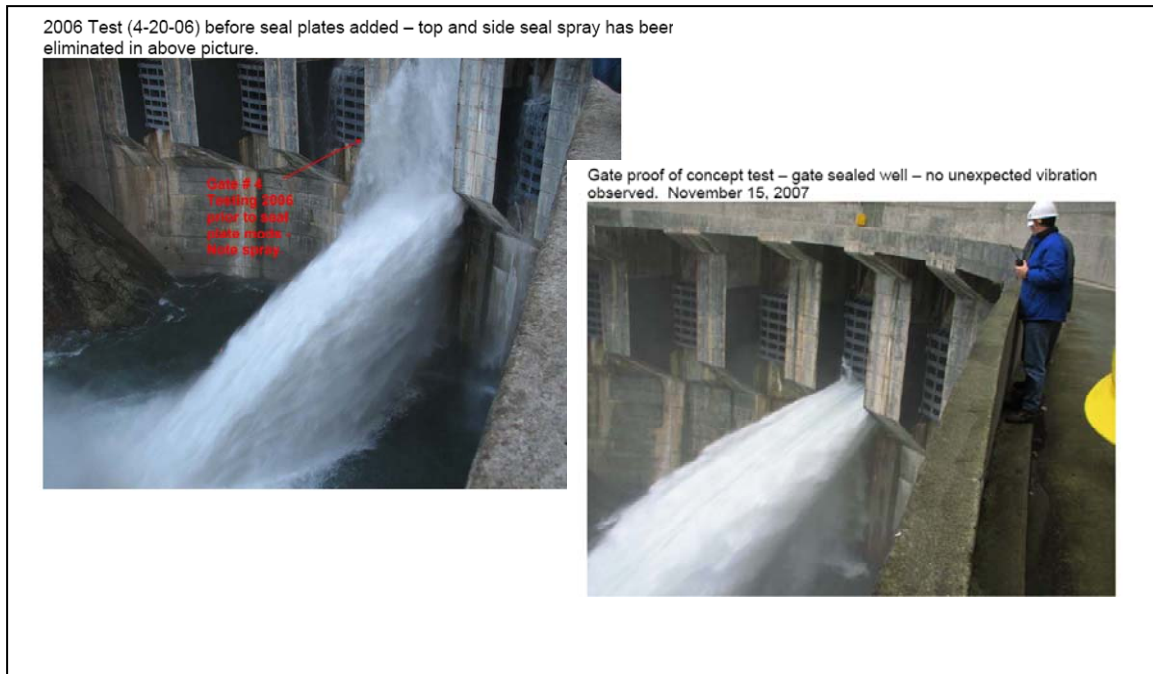
Figure 7. Throttled Sluice Gate Operation (Before and After Seal Plates)

Testing was performed with Sluice Gate 4 during 2008 with sealing plates in place. The performance was better than without the sealing plate in place (see Figure 7). The water no longer leaked in the space between the gate and the seal. The expanding jet, however, impacts the gate slot. Further modifications are required to keep the flow away from the gate slot before the system is ready for long-term reliable use. Use of deflectors within the sluice gates has been examined as the preferred method to direct the water away from the gate slots.

Figure 7 highlights two photographs. The left photograph shows gate discharge before seal plates were added to Sluice Gate 4. The right photograph shows gate discharge after seal plates were installed. Note the decrease in spray.

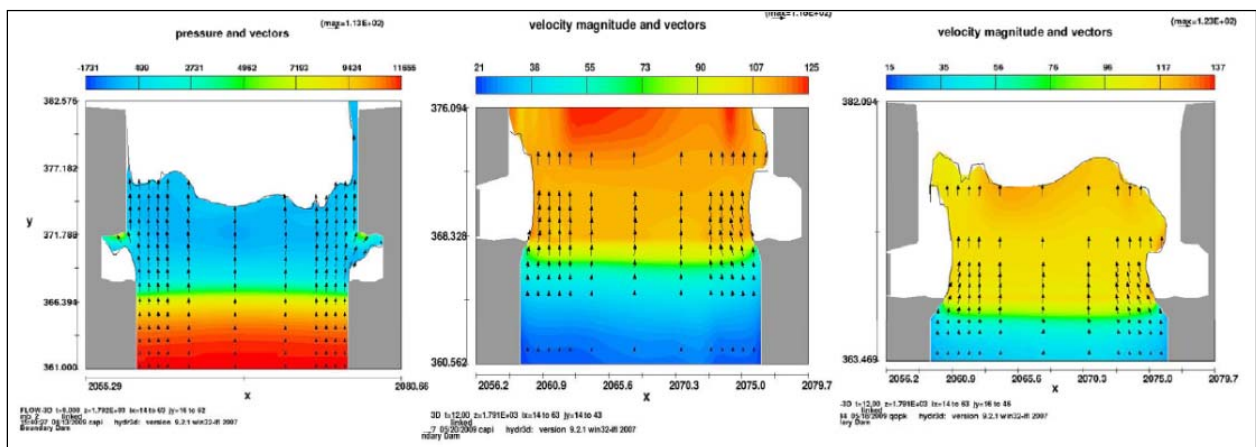
Figure 8. Sluice Deflector CFD Modeling Results

CFD analysis was performed to determine shape (see Figure 8). Field tests and old physical model study tests show that the high velocity jet can expand to impact on the downstream gate guide. Numerical models showed a similar trend. Runs were undertaken to evaluate the possible implementation of “deflectors” to shield the guides. The gate was assumed to be restricted to a four-foot opening.

The deflector profile is a flat 1.33:1 sloped plate, with a nine-inch high trailing edge. The deflector profile is integrated into the geometry sluiceway side wall, up-sloping invert, and the nine-inch fillet radius in between. The height of the deflector is 60 inches at the downstream opening of the sluiceway. The top of the deflector is capped with an upward sloping cover plate that blends into the vertical sluiceway wall. To prevent flow separation and potential cavitation damage, the leading edge weld is finished with a smooth profile blended into the deflector plate. The deflector is configured as a welded steel structure that is then welded to the sluiceway liner. In order to avoid fit-up and connection difficulty that would be encountered with a completely assembled shop fabricated deflector assembly, the deflector is configured as three components that are field welded to the sluiceway liner. The shop-fabricated components consist of the main deflector (skin plate and rib assembly), the lower deflector-to-fillet plate, and the top closure plate.
