BANK EROSION CONTROL AT FREDERICKHOUSE DAM, ONTARIO

Shiqiang Ye, P.Eng., Ontario Power Generation, Niagara-on-the-Lake, ON, Canada

ABSTRACT

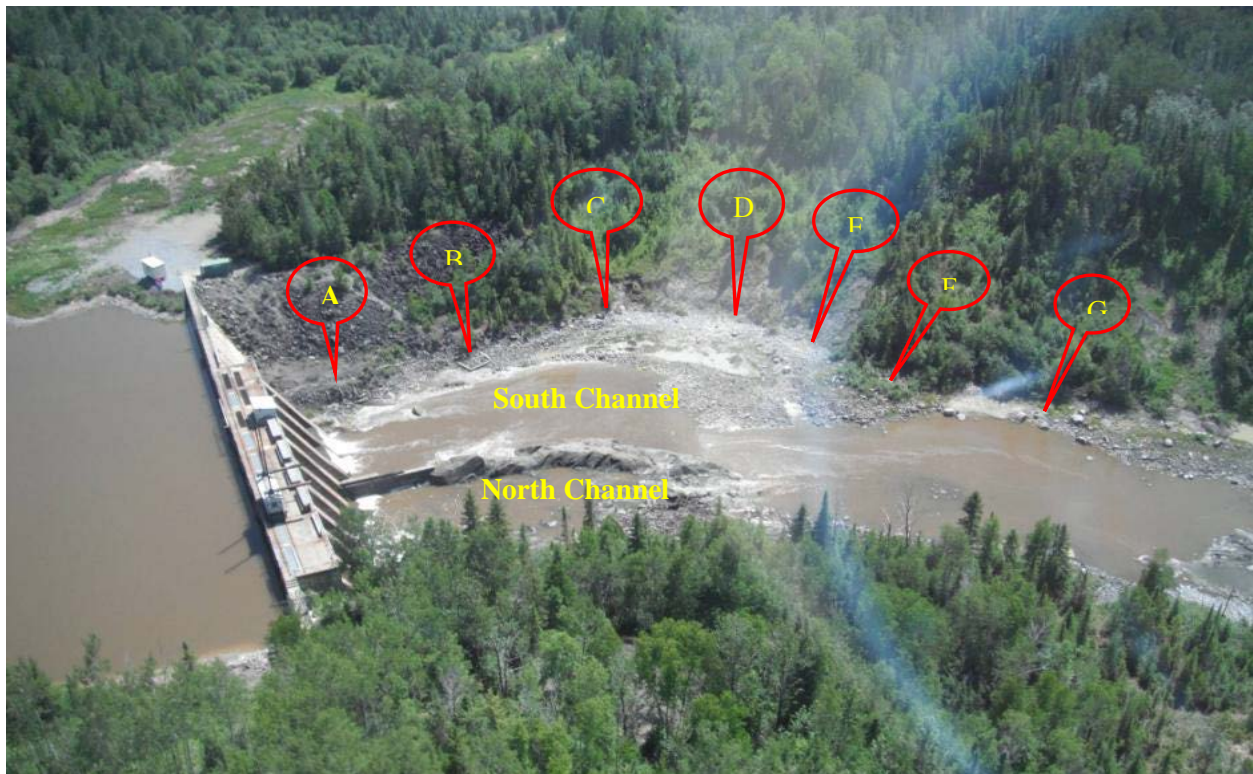
The dam's downstream channel is divided by a 60 m long bedrock outcrop on which a training crib mounted to an elevation of 865 ft (263.6 m) during original construction. In addition, there were 30 m long timber cribs with rockfill to elevation of 865 ft (263.6 m) built (refer to B in Figure 1), next to that, a 40 m long rip-rap of a 1:1.5 (V:H) slope was constructed (refer to B and C in Figure 1) in the south bank (left bank). These features were intended to provide erosion protection along the south bank.

At some point since completion of this dam, the training cribs on the 60 m long bedrock outcrop were washed away. The south bank experienced serious erosion: half of the crib was damaged (A to B), 40 m rip-rap slope was flattened and its downstream native soil bank was washed away by up to 8-10 m (refer to D and E). South bank slope is 28 m high. The slope toe erosion mainly occurred along a 60 m long bank between C and F. Point F is a location where no significant erosion occurs. Point G, minor erosion, is located at OPG property boundary.

Slope toe erosion at south bank led slope failure. In spring of 1995 (Paulen 2002), heavy and prolonged rainfall combined with unusually rapid snowmelt, triggered a large landslide, up to 8000 m³ to 10000 m³, at south bank (refer to C to E).

Figure 1: Frederickhouse dam and its downstream channel on 7 July 2010

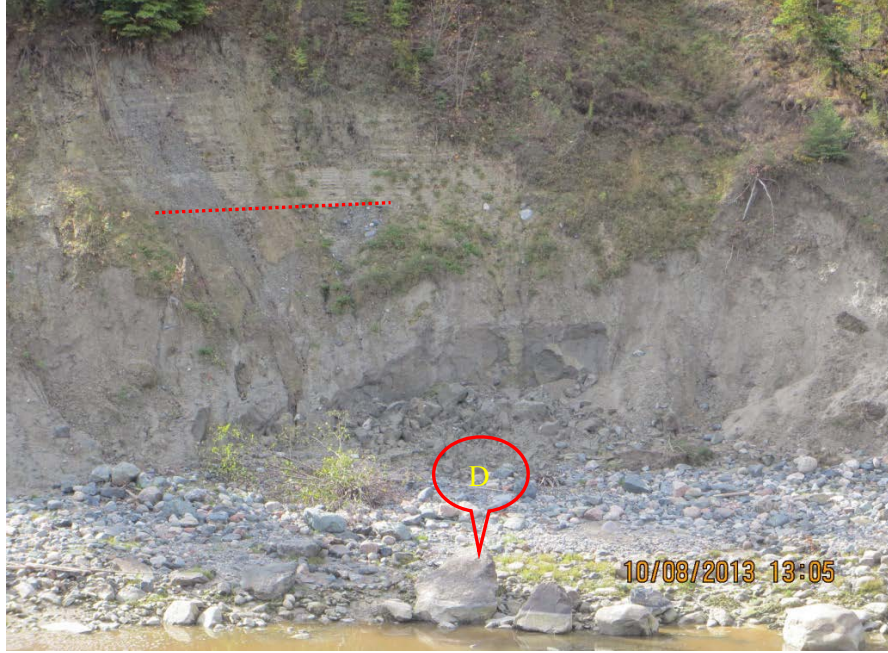
Although current slope state is globally stable (Figure 1), the surface and shallow failures have been occurring, in particular, continuation the erosion of Matheson till (Figure 2) during the high flood seasons could lead to further slope failure.

Figure 2: Ojibway silt/Matheson till at 266 m. Till is eroded in high flows.

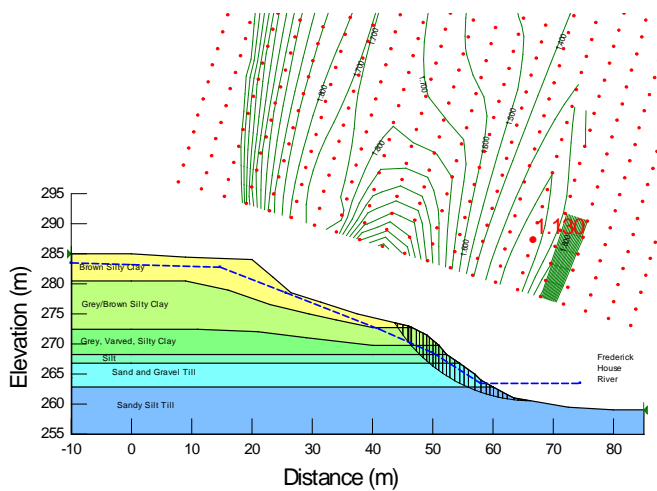
Figure 3: Global failure without a berm

The above parameters are used to model current slope state which has a Factor of Safety (FOS) are 1.02 (surface failure) and 1.13 (global failure in Figure 3), respectively. That reasonably well describes the present state of the slope.

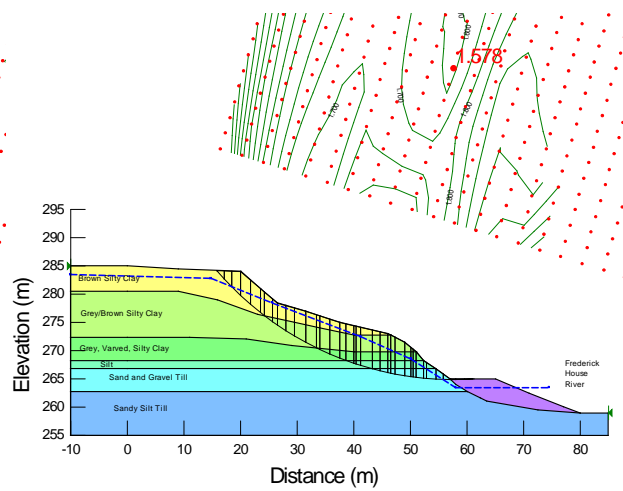
Figure 4: Global failure with a berm

A proposed stabilization rip-rap berm (Figure 4) increases the Factor of Safety (FOS) of global failure to 1.6 which meets requirements of highway and OPG dam safety standards.

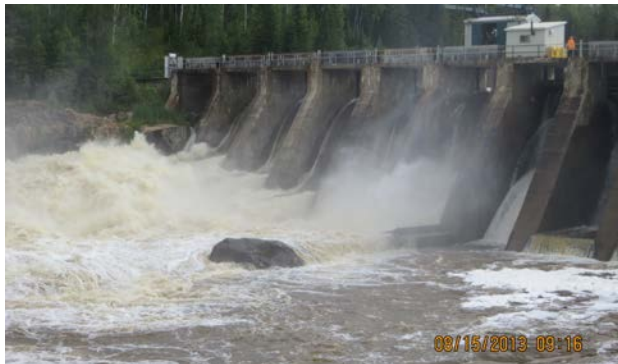
Figure 5: Flow pattern looking toward dam

Flow in the downstream channel was very turbulent (Figure 5 and 6), including features such as hydraulic jumps, flash overtop bedrock crops, reverse flow, vortexes, and sediment suspended along the slope toe.

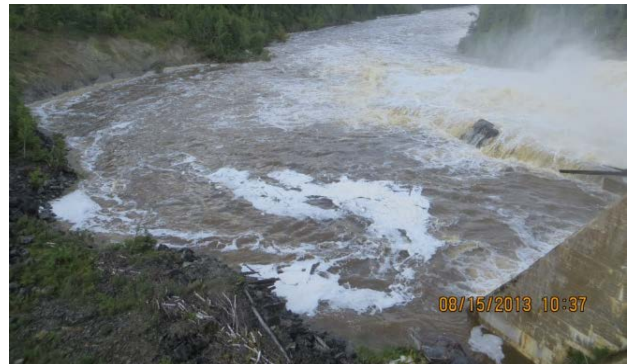
Figure 6: Flow pattern at slope toe

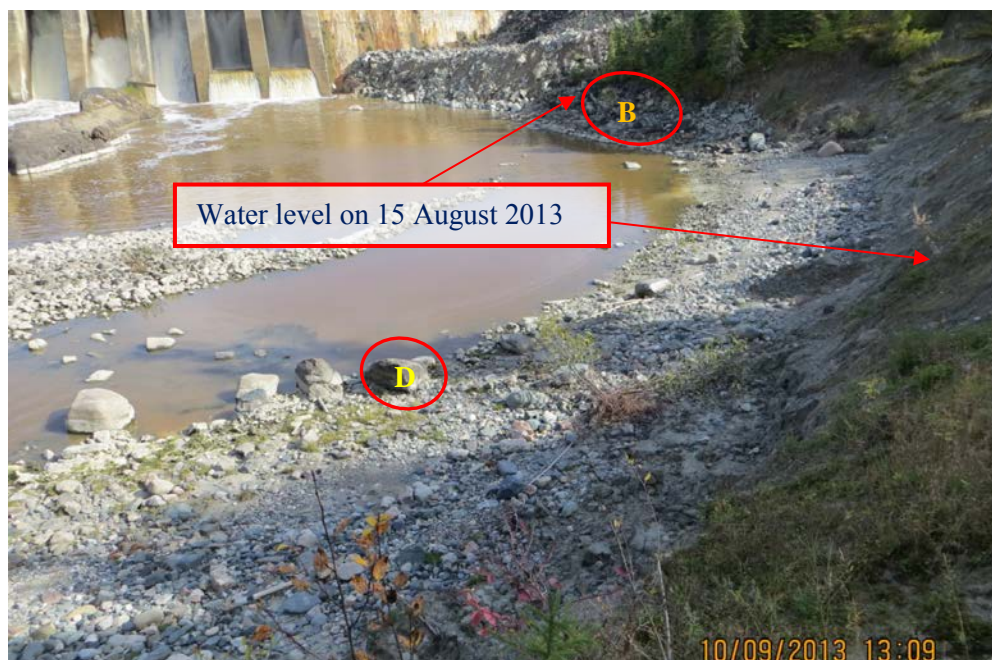
Figure 7: Water level marks and erosion after high flows

Based on a topographic map and compared with on-site observations on October 9 (Figure 7), the water level is visually estimated to be at 261.5 m for a flow of 221.7 cms on August 15, 2013.

There was erosion evidence along the toe of slope, such as new fallen trees, fresh soil scarps. Existing riprap also experienced erosion and movement. Historical placement (1938) of angular riprap of 0.6 m mean diameter along a 40 m segment (B in Figure 7), has been eroded by flow. Rocks over 1m (D in Figure 7) didn't show signs of movement, suggesting 1m diameter armourstone should resist the erosion.

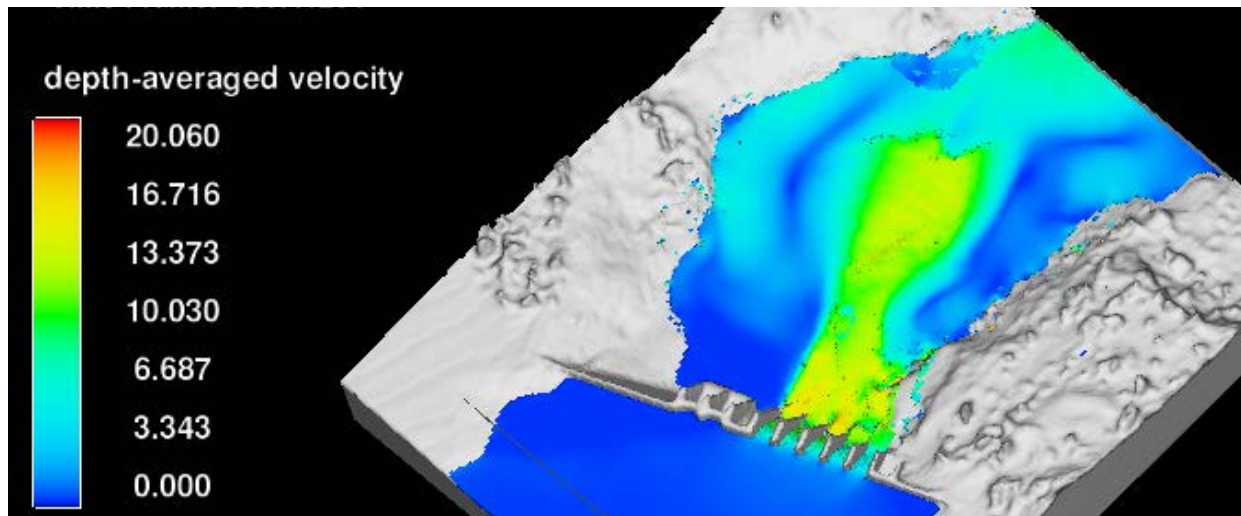
The simulated summer design flow pattern is shown in Figure 8 and its hydraulic conditions in the downstream channel are summarised in Table 2.

Photo 8: Depth-average velocity pattern of design flow (400 cms)

The Flow-3D model also simulated flow patterns affected by a proposed berm at toe area along the south bank slope and indicates the flow would be improved and reduced flow erosion capability.
