Watching **Casting Defects**

Wanliang Sun, Charles E. Bates, University of Alabama at Birmingham, Birmingham, AL

X-rays enable us to observe real-time mold filling in lost foam and conventional sand molds. These observations permit foundrymen to observe the reasons for casting defects as they are formed, rather than guessing at the causes after the casting cools. This capability is invaluable in producing quality castings and reducing scrap rates.

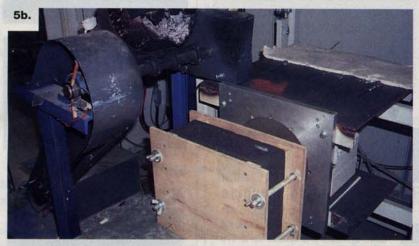
5a.

Figure 5.: Conventional sand casting; a) furan resin bonded mold halves; and b) pouring arrangement in the lead vault.

Filling open cavity molds can also be examined with the X-ray system. The appearance of furan resin bonded mold containing a 4 in. x 4 in. x 0.5 in. (102 mm x 102 mm x 13 mm) plate is illustrated in Figure 5(a), and the pouring arrangement in the vault is illustrated in Figure 5(b).

The casting has a tapered sprue, a horizontal runner, and a bottom ingate. The gating area ratio was 1:1.1:1.1 to produce a slight choke at the bottom of the sprue. A Class 35 gray iron was poured at approximately 2550° F (1400° C) after inoculation with 0.25 percent silicon as foundry grade FeSi. The vertically split mold halves were clamped using threaded rods through wooden backing boards. There were spacers between the mold and the backing boards to allow gases to escape in a normal fashion. The mold has a pouring basin built into the top, as illustrated in Figure 5(a).
