## TUNNELS AND PENSTOCKS OF THE NAM THEUN 2 HYDROELECTRIC PROJECT

Neil N. Heidstra, P.Eng, Klohn Crippen Berger Ltd., Vancouver, BC, Canada

### ABSTRACT:

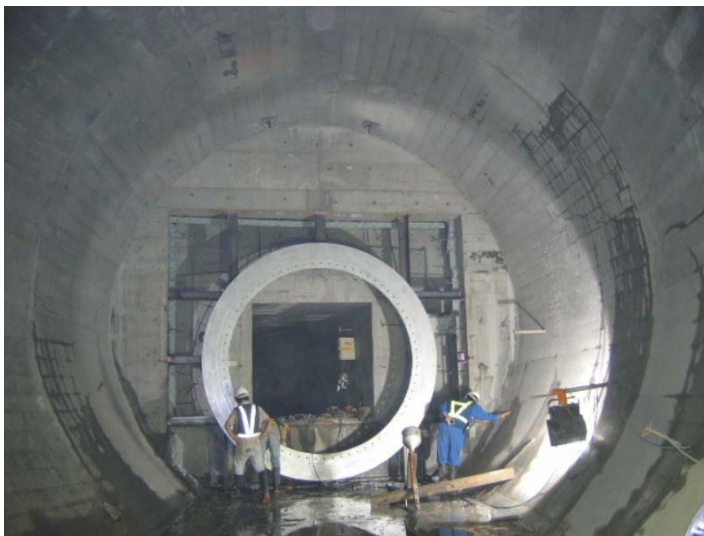
Figure 4: Headrace Access Tunnel Opening

It was decided to design the door as a circular door with a hemispherical dome as the main water retaining structure. The arrangement of the door is such that the inscribing circle of the inner flange of the door and door frame contains the minimum opening size of 2 m square. Figure 4 is a photograph of the concrete plug in the headrace access tunnel with the door opening prior to installation of the door itself. The door is hinged on one side and when closed, is bolted from the headrace access tunnel side. Figure 5 is a photograph of the door being installed. “O” ring seals on machined flanges of the door and embedded door frame provide the watertight sealing arrangement. A concrete ramp on the headrace access tunnel side provides access to the 2 m square opening through the door and a portable ramp provides similar access on the headrace tunnel side.

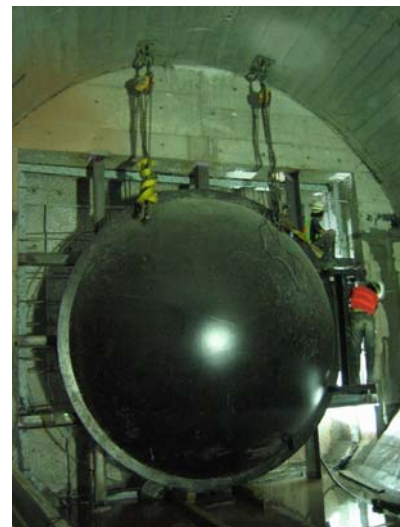
Figure 5: Headrace Access Door

The door was analyzed by finite element analysis and as the hemispherical dome is in compression and therefore sensitive to potential buckling, a buckling analysis was also performed. For this analysis, the first buckling mode shape of the dome was computed, and then the geometry of the dome in the finite element model was altered to include the maximum specified fabrication out-of-tolerance dimensions conforming to the first buckling mode. The analysis was then continued by increasing the applied external pressure until yield or buckling of the dome occurred.

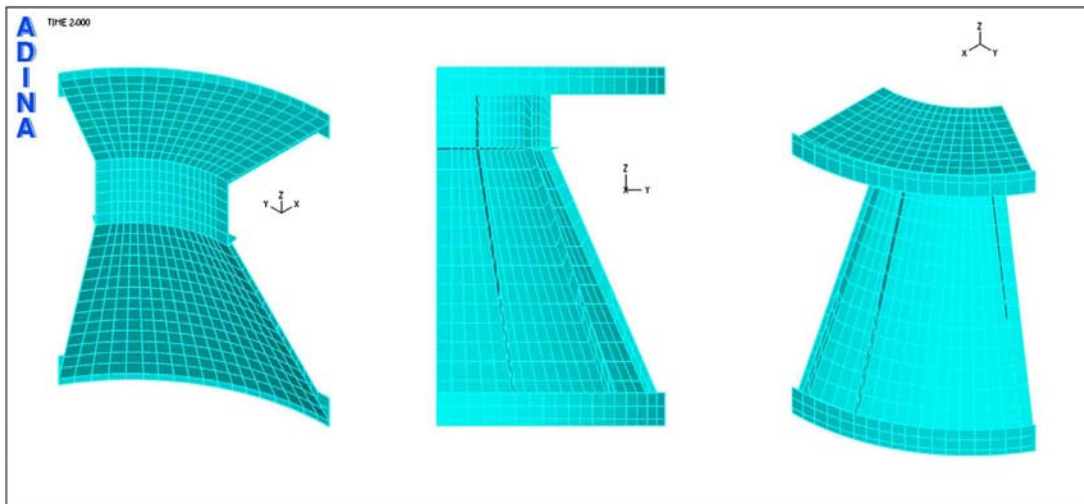
Figure 7: Finite Element Model of the  $60^\circ$  Segment of the Surge Shaft Orifice

The orifice was fabricated in three pieces and each piece lowered separately into the shaft and bolted to the embedded flanges. Once these individual segments of the orifice were in place, closure plates between these segments were then welded in place to complete the orifice. A manhole is provided into the orifice to complete the welding, bolting and corrosion protection. The finite element model used for the design of the orifice is presented in Figure 7, showing the  $60^\circ$  segment of the orifice that was analysed.

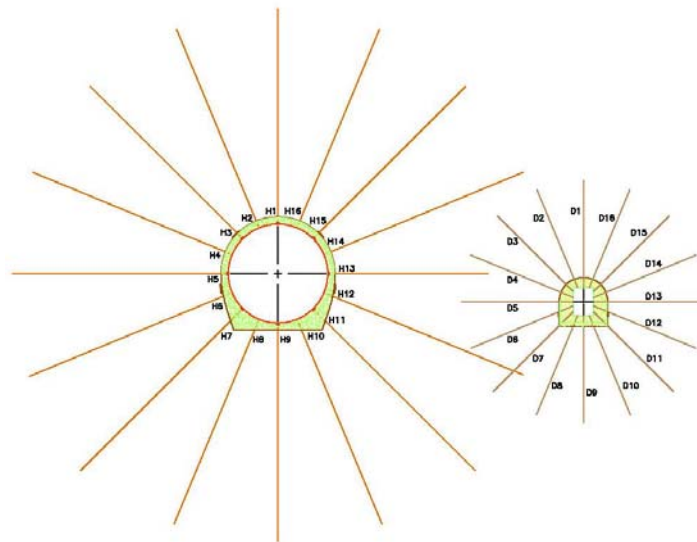
Figure 9: Cross Section through the High Pressure Tunnel and Drainage Tunnel at the Grout Cut-off

The grout cut-off consists of 16 rings of grout holes at 2 m centres drilled through the steel lining. Figure 9 presents a typical cross section through the grout cut-off zone. Void grouting to fill any voids in the crown of the tunnel that occurred during the concreting of the liner was initially done. Then each ground consolidation hole was drilled and grouted in a sequence that progressively grouted the rock further out from the tunnel. The original grouting sequence was developed for the worst case scenario for the rock permeability. During construction, it was found that most grout takes were very low and that the rock was generally tight in this area. Consequently some grouting stages were reduced or eliminated in areas of very low grout take.

The concrete plug in the drainage tunnel had to correspond to the full length of the grout cut-off. The length of the plug is much longer than that required to resist the water pressure acting on the upstream face of the plug. Therefore only the first 5.2 m of the plug in the drainage tunnel was solid concrete. Behind this solid portion, the tunnel was lined with reinforced concrete to withstand the external groundwater and grouting pressures. The space inside the gallery in the concrete plug is sufficient to use a drilling machine to drill and grout the ground consolidation grout holes required for the grout cut-off.

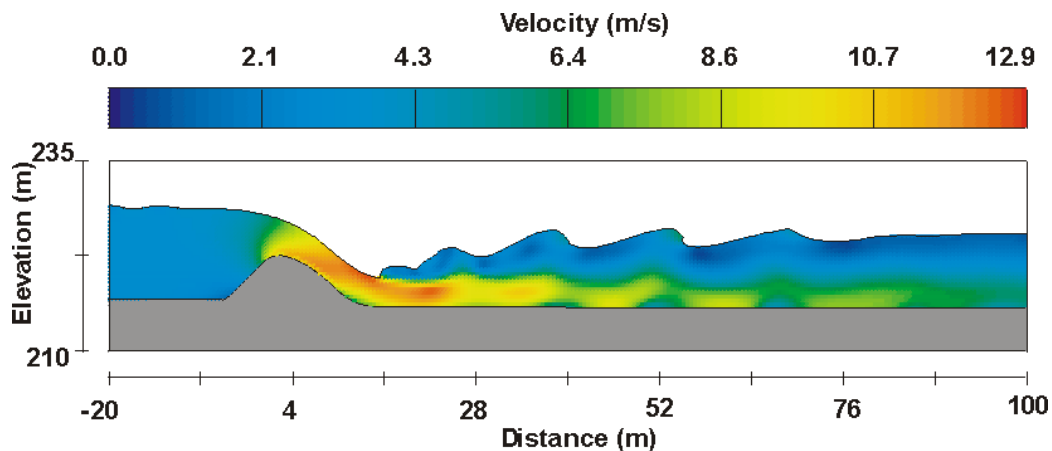
Figure 1: Velocity profile through the original Outlet Structure for the 1997 flood simulation

- Numerical model study results indicated the presence of a high velocity jet that formed along the bed downstream of the structure, as shown in Figure 1. This jet exposed downstream sections of the basin and rock channel to velocities of between 8 to 10 m/s (26 to 33 ft/s). The jet was undulating, periodically detaching and reattaching to the channel bottom. This pulsating action could potentially cause erosion in the downstream channel, and also is the primary cause of the large waves discussed in the previous point.

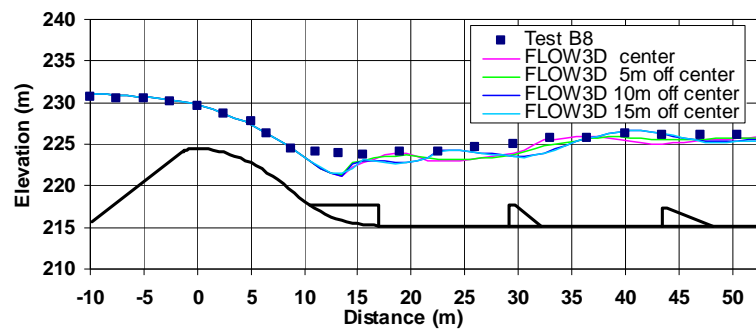
Figure 3: Comparison of numerical and physical model water surface profiles

is very good. Figure 3 compares the water surface profile computed within the numerical model to measurements taken in the physical model. Again, the match between the two is very good. The close match verifies the numerical model's ability to replicate real world hydraulic phenomena.

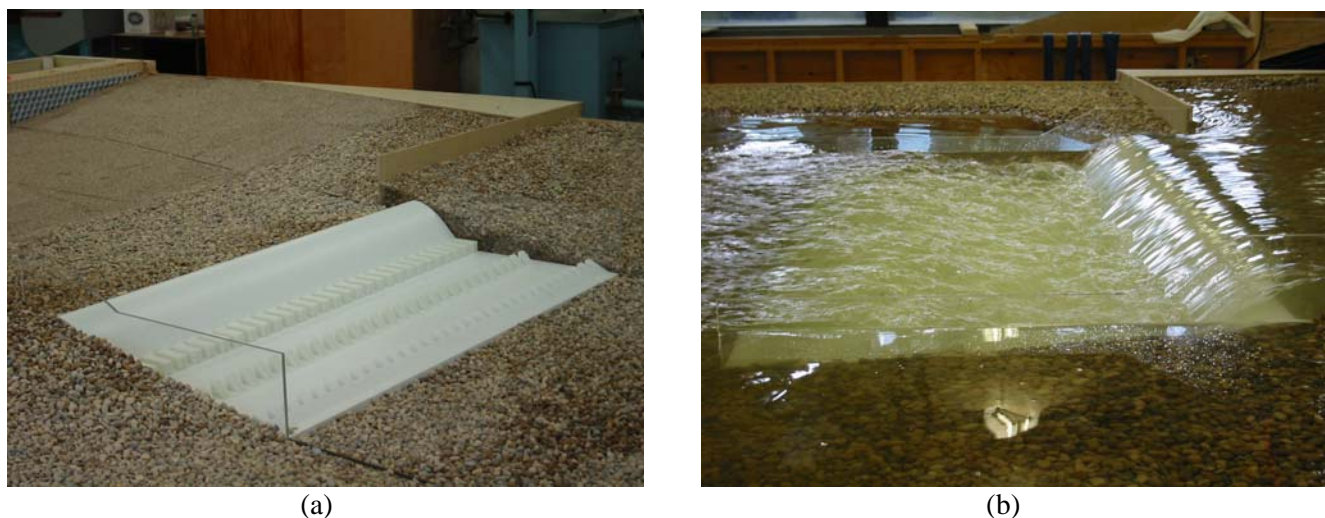
Figure 4: Physical Model (a) Dry (b) Passing design flow

Water was pumped from a storage sump through a V-notched measuring weir before entering the model through a headtank that uniformly distributed the flow across the upstream end of the model. Tailwater levels were set with a tilting gate at the downstream end of the model. The tailwater stage discharge curve utilized reflects the total discharge of the Red River downstream of the confluence with the Floodway Outlet Channel. This discharge includes the outflow from the Floodway, the Red River flow that is passed thru the City of Winnipeg including the contribution from the Assiniboine River.

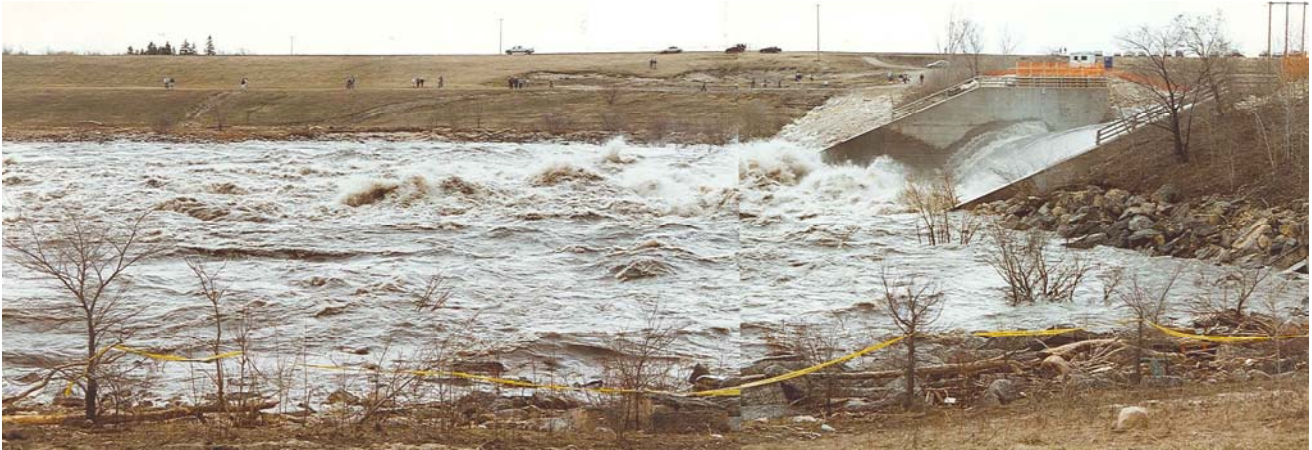
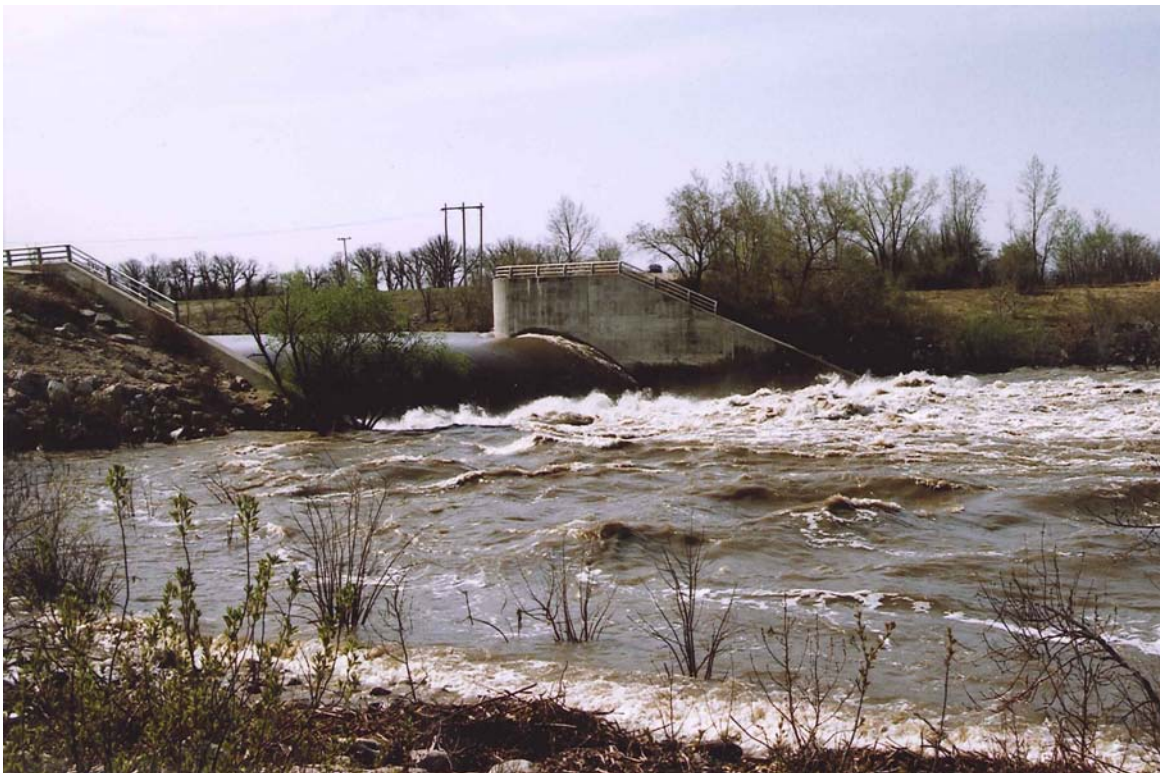
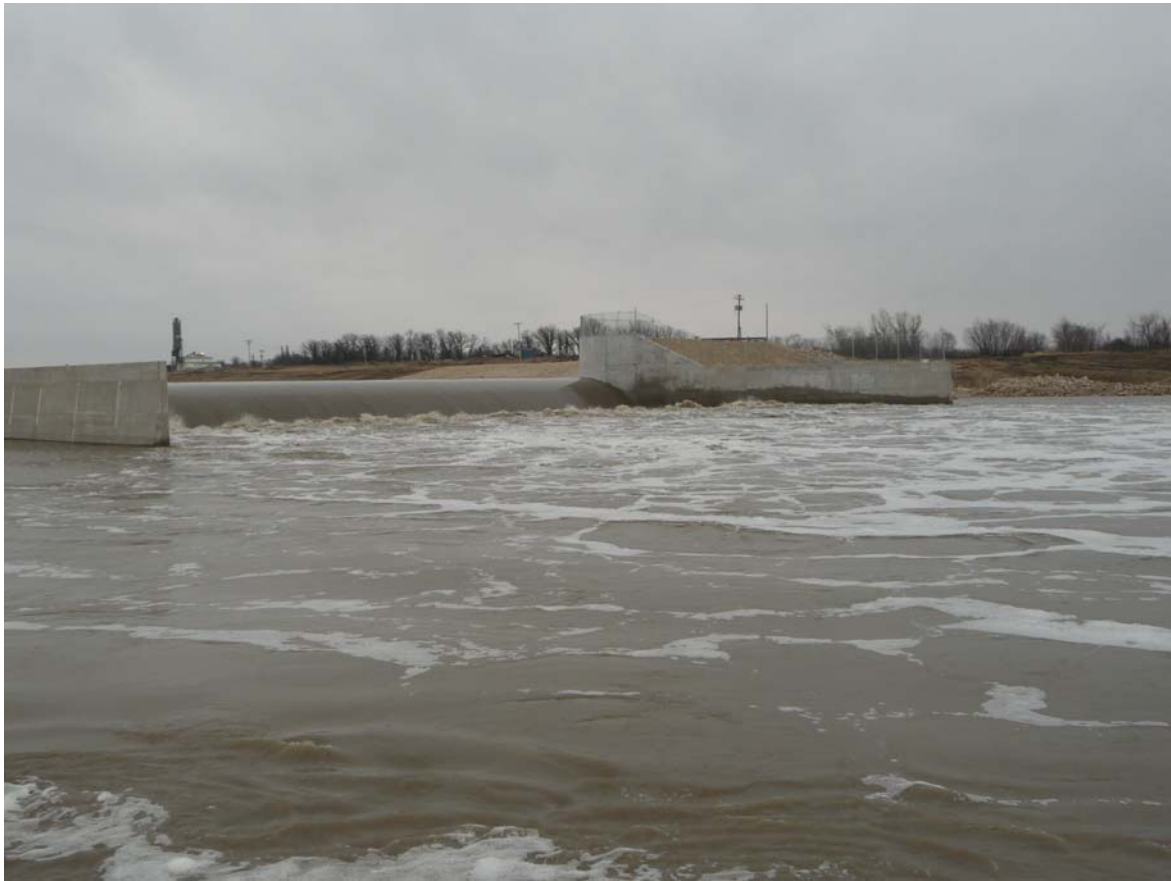
The 2009 flood provided an opportunity to evaluate the effectiveness of the new Outlet Structure's ability to dissipate energy. Figures 6 to 8 show photos of downstream flow conditions taken near the peaks of the 1997, 2006, and 2009 floods respectively. Energy dissipation associated with the original Outlet Structure resulted in significant return currents and wave action being generated. These turbulent flow conditions persisted far beyond the confines of the stilling basin and at times had been observed to impact upon the west bank of the Red River opposite the Outlet Structure. In comparison, the downstream flow conditions observed during the 2009 flood can be seen to be significantly calmer with the majority of the energy dissipation taking place within the limits of the Outlet Structure wing walls. These full height walls were also seen to effectively eliminate the generation of downstream return currents. It should be pointed out that the peak Floodway flow during the 2006 flood (Figure 7) was 10,500 cfs lower than the peak flow experienced during the 2009 flood, yet the downstream flow conditions are distinctly less chaotic, which demonstrates the effectiveness of the new structure.

Figure 6: Flow conditions – 1997

Figure 7: Flow conditions - 2006

Figure 8: Flow conditions – 2009

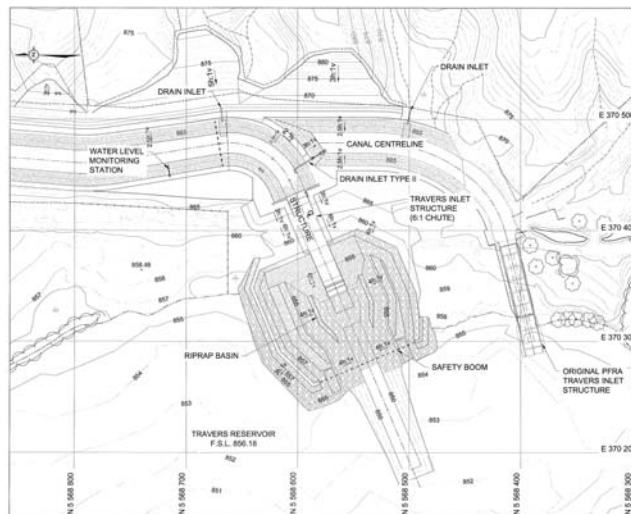
Figure 6: Travers Inlet site plan

The Travers Inlet structure is situated in the SW ¼ Sec. 15-15-21-W4M at the downstream end of the 3 km long McGregor-Travers connecting canal that carries flow released from McGregor Reservoir into the north end of Travers Reservoir. The connecting canal is located along the east side of the valley at a level that is approximately midway between the FSL in McGregor Reservoir at 874.38 m and that of Travers Reservoir at 856.18 m. During canal operation, the head drop at the Travers Inlet structure varies from approximately 10 m with Travers Reservoir at its FSL to about 13 m when it is drawdown to normal low water level. The original Travers Inlet structure was constructed by the PFRA in the 1950's and had a design capacity of 51 m<sup>3</sup>/s. The new structure is located approximately 180 m upstream of the original structure and its design capacity has been increased to 79.3 m<sup>3</sup>/s. Although a variety of structure types were considered, a fixed weir chute structure with a horizontal hydraulic jump stilling basin was designed and constructed at the new site. The location of the Travers Inlet structure relative to the other project components is shown on Figure 1. The Travers Inlet site plan is shown on Figure 6.

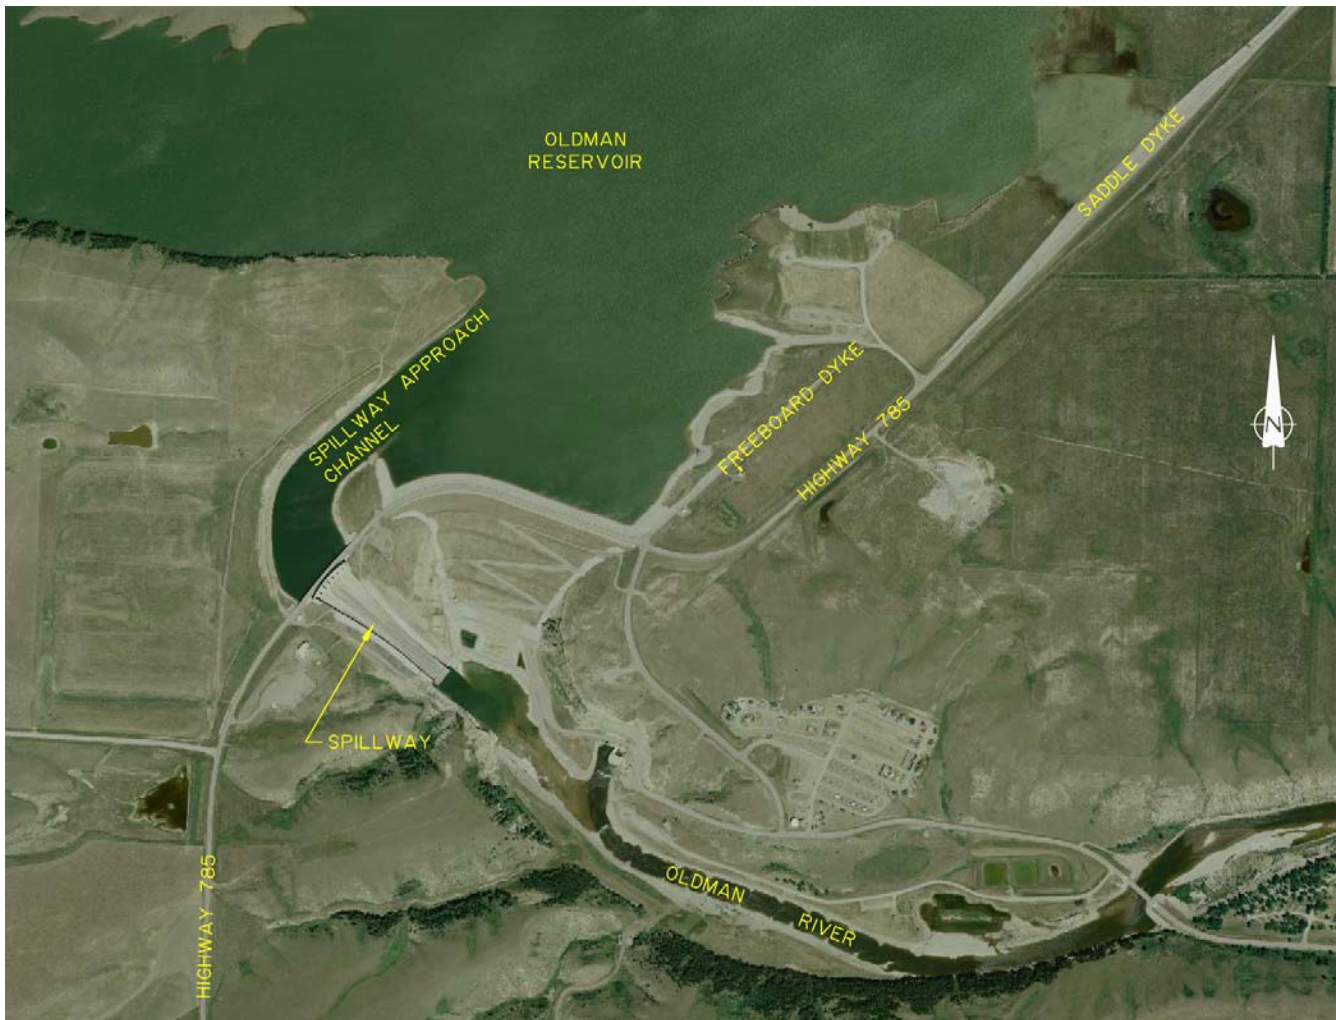
Figure 2: Layout of Oldman Dam and Spillway (Photo courtesy of Tarin Resource Services Ltd.)

In accordance with the CDA Dam Safety Guidelines (2007), the dam is classified in the “Extreme” consequence category. The spillway is thus designed to handle the peak outflow associated with a Probable Maximum Flood (PMF) of 9320 m<sup>3</sup>/s, at a maximum water level of 1124.5 m elevation at the dam (1 m freeboard).

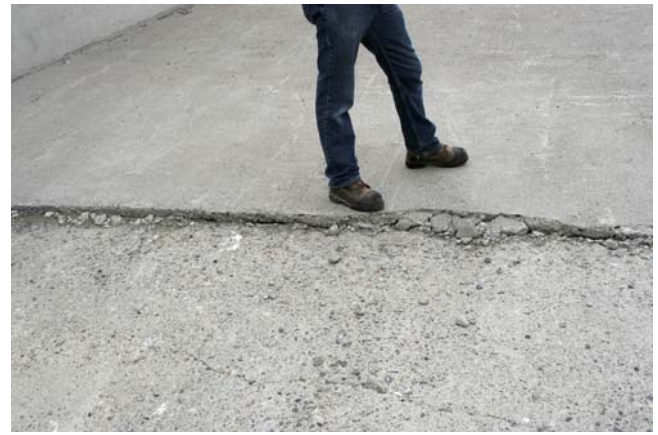
Photo 4: Up thrust on spillway mud slab joint.

In summary, while it is known that movement is occurring along a shear plane in the foundation of the spillway, there is little evidence of this movement in the spillway structure itself. Minor distress is seen in the mud slab along the outside of the spillway and moderate distress is seen in the lower drainage manholes, which cross the elevation of the shear plane.

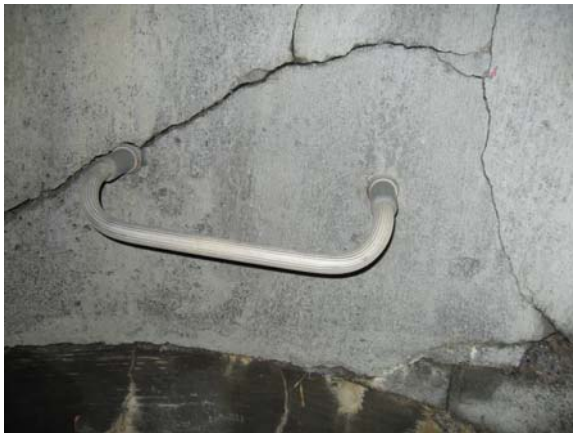
Photo 5: Cracking in drainage manhole barrel.

The profiles indicate that the most significant movement is in the elevation 1065 m to 1070 m zone, which is at the same elevation as the cracking noted in manholes MH7L and MH7R. While accumulated movements are significant, over the last 10 years, movement rates have been low. Further discussion of movements adjacent to the spillway chute is included in Section 4.6.

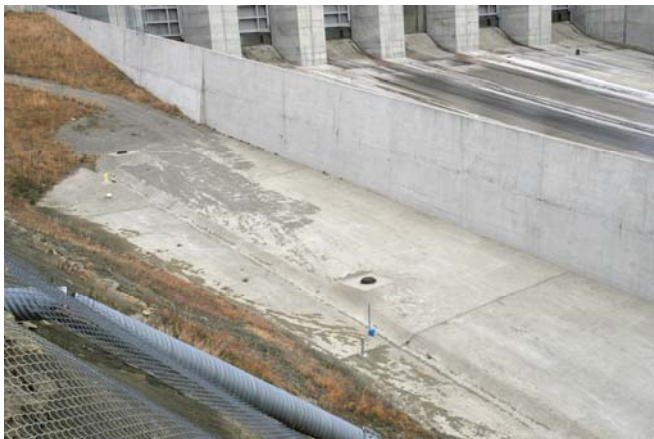
Photo 7: Right side of spillway showing drain manholes, extensometers (yellow; middle left) and SI (blue).

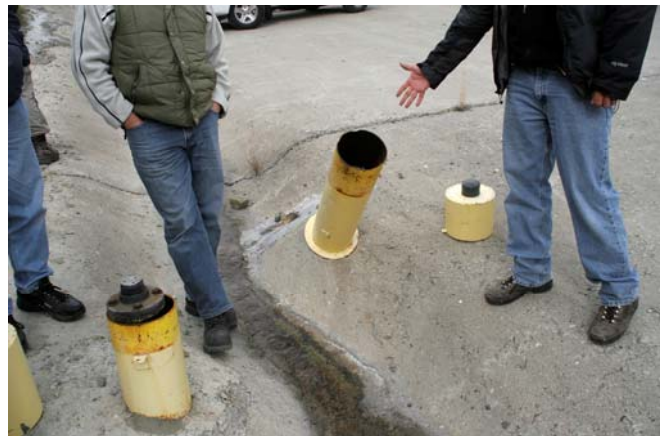
Photo 8: Vertical extensometer (on left, showing head) and inclined extensometer (in middle).

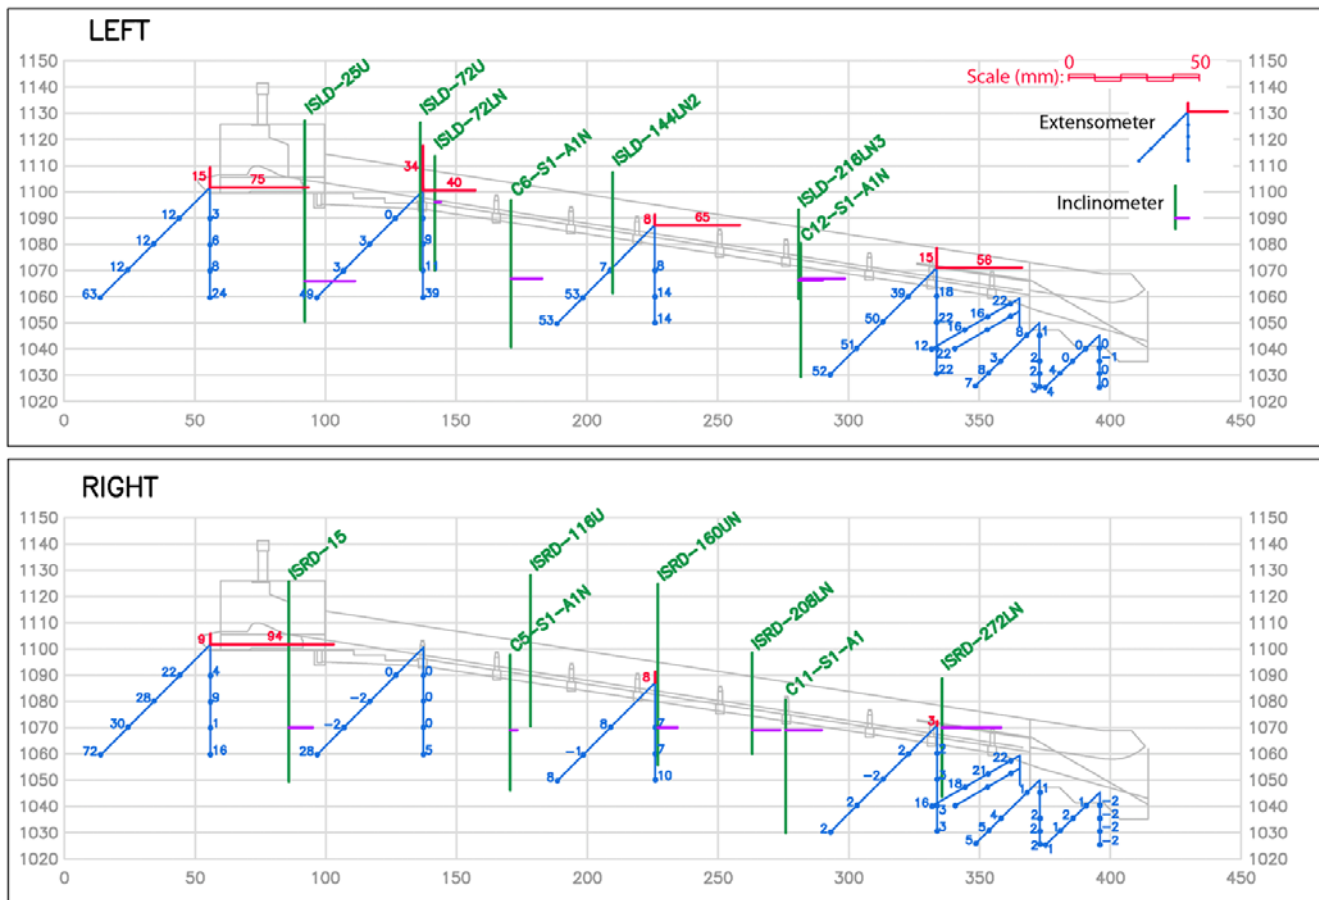
- The extensometers are shown in blue, and the movement of each anchor point with respect to the extensometer head is also shown in blue.

Figure 7: Plot of extensometer movements on left and right side of spillway. Values in blue are displacements of anchor points with respect to extensometer head (mm); values in red are interpreted displacements of head, resolved into X and Y components (mm). Magenta lines show depth of main displacement in SIs. [Axes of plots: vertical is elevation (m) and horizontal is distance along spillway (m)]
