Analysis of the Cause for the Collapse of a Temporary Bridge Using Numerical Simulation

Changsung Kim, Jongtae Kim, Joongu Kang

Water Resource Research Department, Korea Institute of Construction Technology, Goyang, Korea
Email: csckim@kict.re.kr

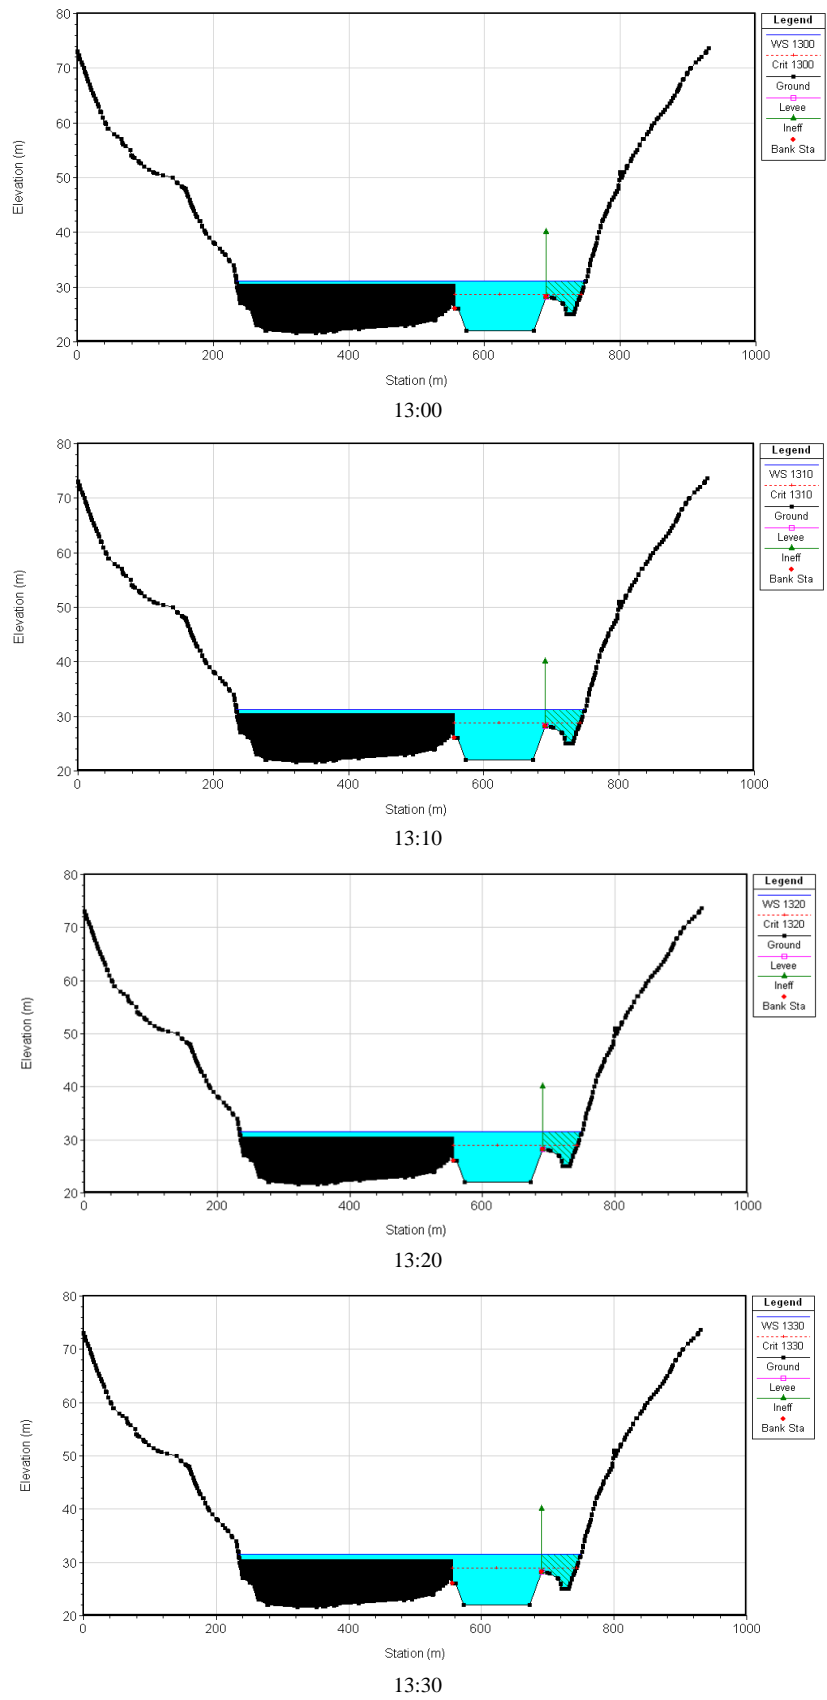
based on the time at which the collapse of the temporary bridge occurred (August 27 at 13:30), and it was performed at a total of four conditions. The results of the analysis at the four conditions indicated that the average water levels of the cross section were EL. 31.06 m - EL. 31.60 m, and the average flow velocities of the cross section were 5.10 m/s - 5.34 m/s (**Table 1** and **Figure 3**). The results of the numerical analysis showed that the heights of the upper and lower parts of the temporary bridge were 0.60 m and 1.70 m lower than the maximum water level, respectively.

Figure 3. Water-level of the temporary bridge.

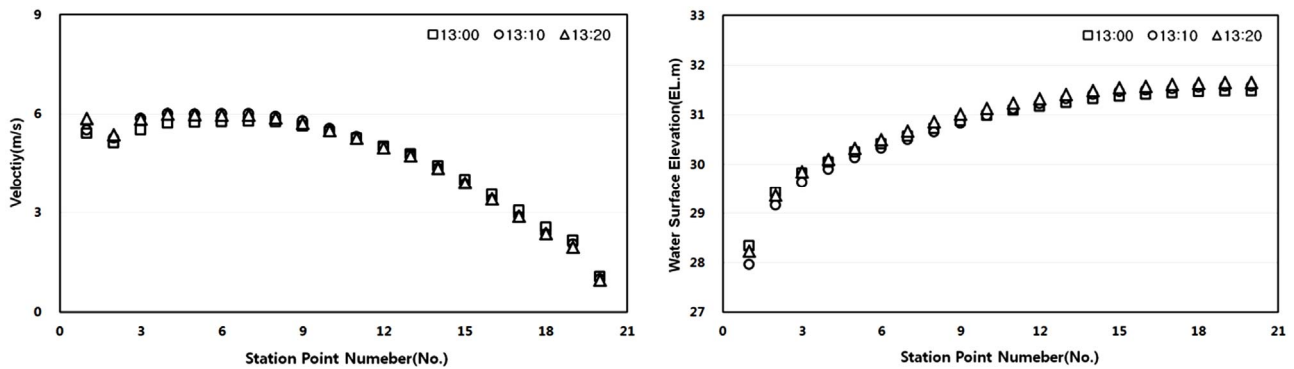
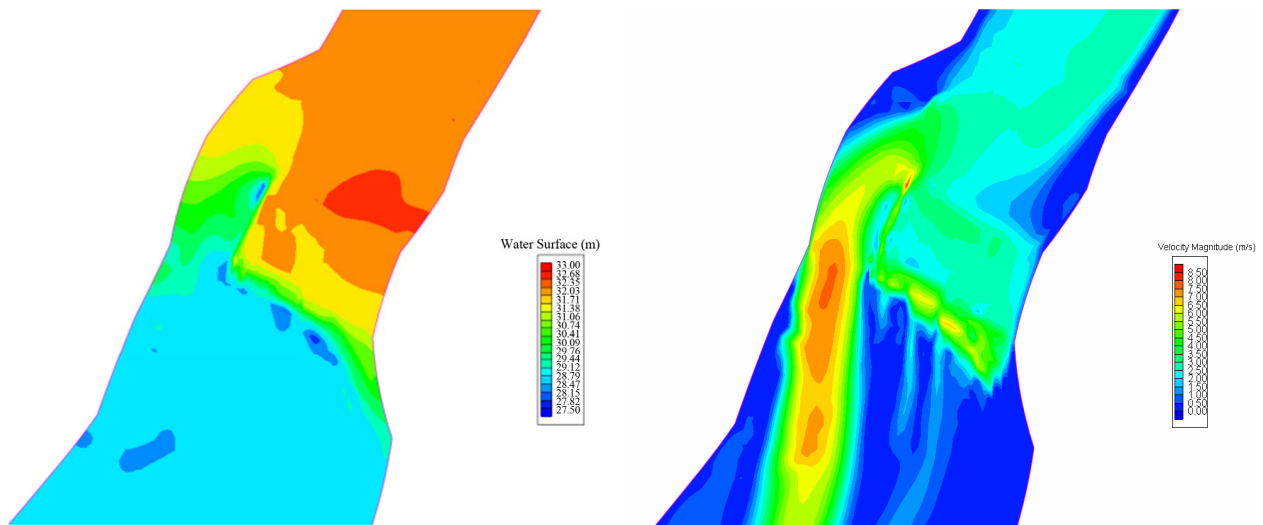
The results of the two-dimensional numerical simulation showed that the main flow of the temporary bridge section was on the left side. It was consistent with the spot at which the collapse of the temporary bridge occurred. For the simulated section, the maximum flow

**Figure 4. Water level and velocity around temporary bridge (CCHE2D).**

Figure 5. Numerical modelling results around temporary bridge (water EL., velocity).

velocity was observed at the end part of the cofferdam (region with reduced cross section). This is thought to be because the flow separated at the end part of the cofferdam in the upstream area accelerated due to the reduced cross section caused by the cofferdam.

and the maximum flow velocity was observed at the end part of the cofferdam. This is thought to be because the flow separated at the end part of the cofferdam in the upstream area accelerated due to the reduced cross-section caused by the cofferdam. For the 13:00 boundary condition where the flow velocity was the highest, the flow velocity at the collapsed 2nd pier was 6.00 m/s, and the water level was EL. 29.89 m.

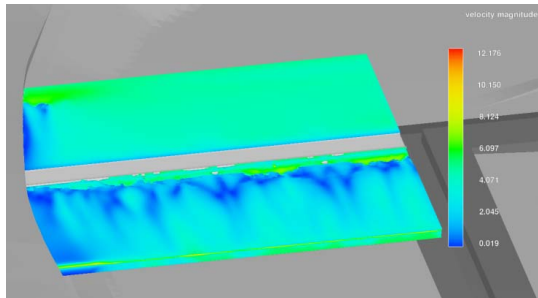
The result of the calculation indicated that during the flow of the flood discharge (6306.94 m^3/s) that occurred just before the collapse of the temporary bridge (August 27, 2009 at 13:10), all the flood discharge was concentrated at the temporary bridge because the river cross section was reduced due to the cofferdam. **Figure 7** shows the flow when the bridge upper deck was completely submerged.

Figure 7. Analysis of 3D flow pattern around the bridge.

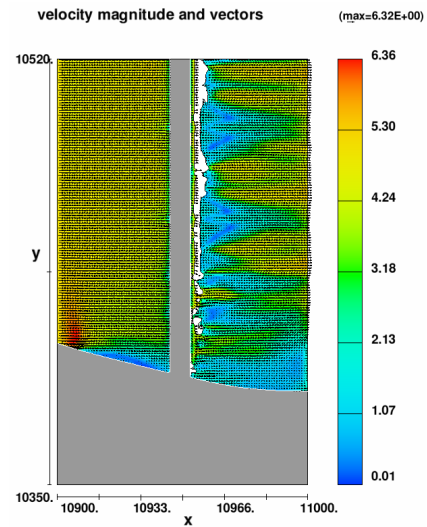
of the two-dimensional numerical simulation. The maximum flow velocity was 6.24 m/s between the cofferdam and the 2nd pier, 4.44 m/s at the 2nd pier, and 6.11 m/s between the 2nd and 3rd piers (**Table 3**). **Figure 8** shows the velocity vectors around the temporary bridge. The flow velocity at the section where the upper deck of the temporary bridge collapsed was about 5.0 m/s.

Figure 8. Velocity vector s around the bridge (WEL. 30.0 m).

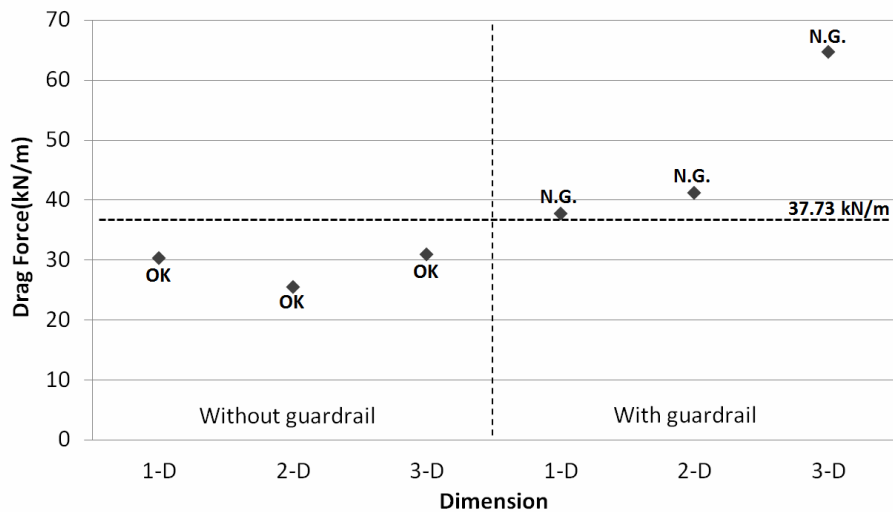
The drag force calculation showed that when the guardrail structure of the temporary bridge was not considered, there was no problem as the calculated values of the one-, two-, and three-dimensional numerical simulations were lower than the design load for the force of the water flow (37.73 kN/m), whereas when the guardrail installed on the upper deck structure was considered, the stability of the temporary bridge was problematic as the calculated values were higher than the design load (**Figure 9**).

Figure 9. Comparison between the drag force and the design load of the bridge.

4) The drag force calculation showed that when the guardrail installed on the upper deck structure was not considered, the calculated values were lower than the design load, 37.73 kN/m, whereas when the guardrail was considered, the calculated values were higher than the design load. It is thought that the actual force of the

water flow applied on the bridge increased due to the accumulation of debris on the guardrail as well as the upper deck.

For temporary bridges, the selection of a uniform design frequency for securing stability is a difficult task. However, it is required to determine a safe design frequency considering the importance of structures and the prediction of the damage on the surrounding area. Also, it is necessary to evaluate the region where the effect of debris is expected to be large.
