Simulation Eliminates Die Casting Scrap

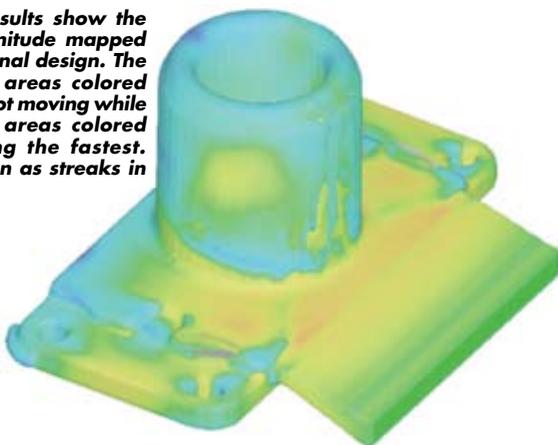
Simulation results show the velocity magnitude mapped onto the original design. The metal in the areas colored dark blue is not moving while metal in the areas colored red is moving the fastest. Voids are seen as streaks in the image.

Velocity magnitude is plotted on the new design. Simulation of the mold filing shows metal flowing evenly into the part.

Littler then turned his attention to solving the problems highlighted by the simulation and came to a final design of three gates on one side of the part all aiming at the post to focus heat and minimize the microporosity in the threaded area. The approach angles of the gate were designed to prevent backflow in the post, and the size of the overflow was increased.

Simulation of the new design showed the metal flowed evenly into the part, eliminating backfilling and reducing turbulence in the gate. Backflow in the flange was reduced, allowing the hottest fluid to enter last. Trial parts were produced and tested using x-ray and break testing.
