Sluiceway Deflector Design as part of the Boundary TDG Abatement Program

The high pressure sluice gates at the Boundary Project have been modified to accommodate throttled flow by addition of steel deflector plates at the sluiceway exit to direct flow away from the gate slots to prevent damage to the gate system.

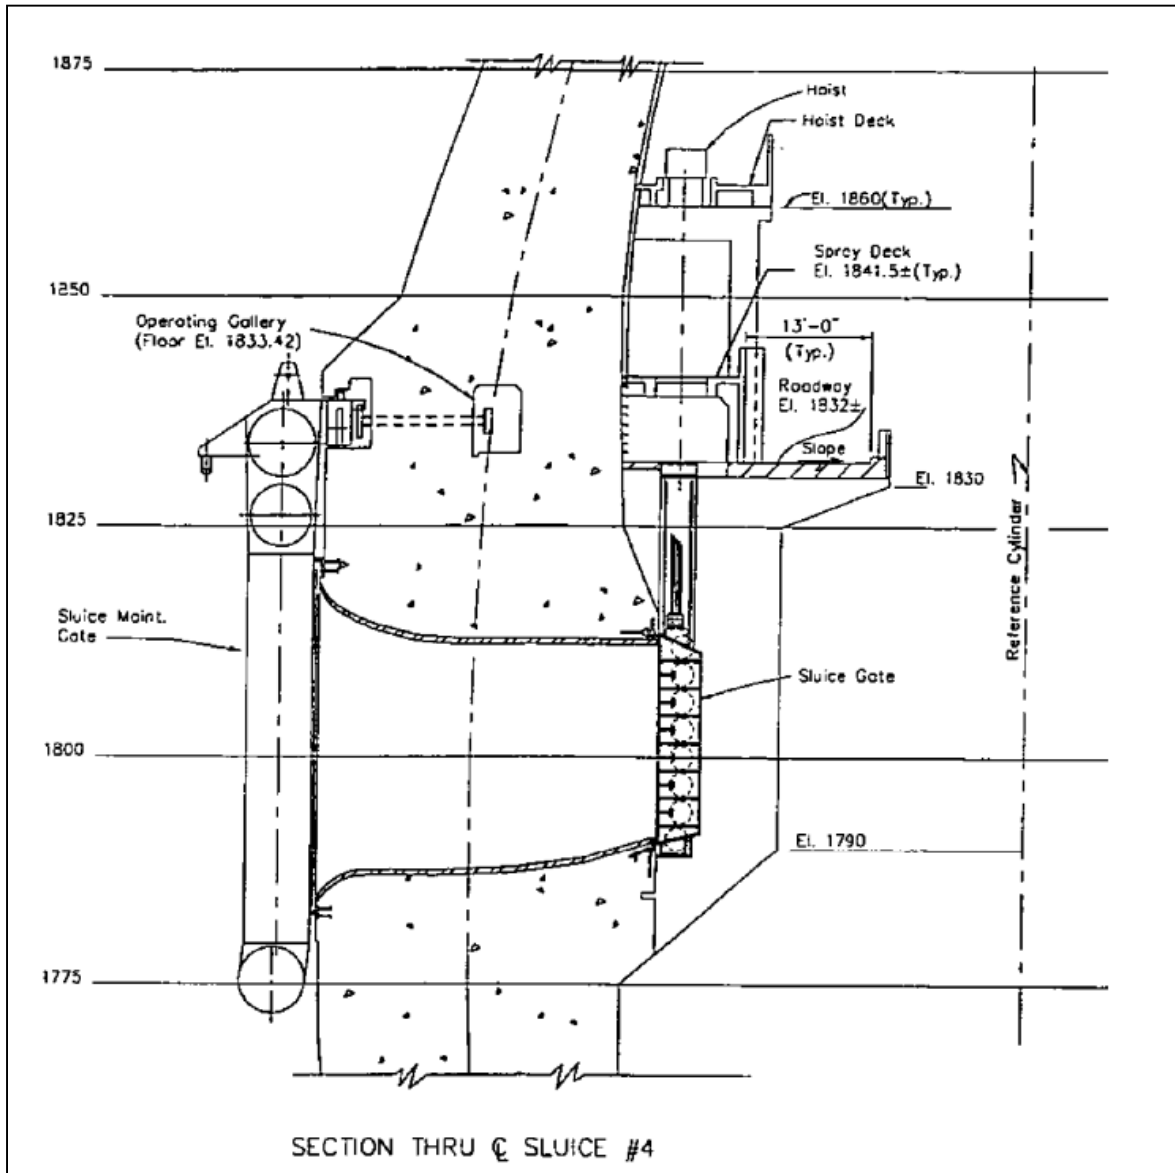
Figure 3. Section Through Sluice Gate

1. Throttle Sluice Gates, which involves modification of the sluice gate sealing system so they can be operated in partially open positions (see Figure 3).
2. Roughen Sluice Flow, which entails modification of the sluice gate outlets to break up and spread flow.
3. Spillway Flow Splitter/Aerator, which entails modifying the spillways to aerate, break up, and spread flow.

partially open, allowing “throttled” flow and break up of the jet, which reduces plunge and thus reduces TDG.
